1. REPORT DATE (DD-MM-YYYY)		2. REPORT TYPE		3. DATES COVERED (From - To)	
04-06-2003		Technical Presentation			
4. TITLE AND SUBTITLE		Usage of Fiber Grating Strain Sensors for Diagnostics of Composite Pressure Vessels		5a. CONTRACT NUMBER F04611-02-C-0007	
				5b. GRANT NUMBER	
				5c. PROGRAM ELEMENT NUMBER

Usage of Fiber Grating Strain Sensors for Diagnostics of Composite Pressure Vessels

16th International Conference on Optical Fiber
Sensors (OFS-16)
October 13-17, 2003
Nara, Japan

E. Udd, M. Kunzler, S. Calvert, and S. Kreger
Blue Road Research

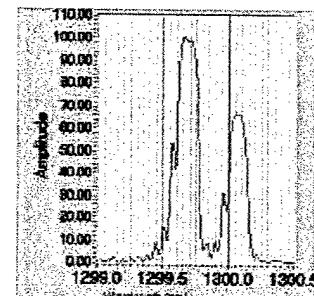
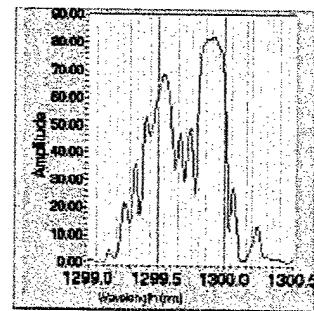
(a)

(b)

Figure 3. Aligned Dual-Axis Fiber Grating Strain Sensor Placed Bare into the Composite Pressure Vessel Near the Area of the Cut Tow Damage Site
(a) Before cure and (b) after cure.

Figure 3 shows the spectral profile of the dual-axis fiber grating strain sensor placed near the area of the cut tow damage site in the pressure vessel. In this case, prepreg tow alignment elements were placed on either side of the fiber grating but not over it, so the dual-axis fiber grating was integrated directly into the composite part. Before cure and completion of the composite pressure vessel, the two spectral peaks corresponding to the two transverse axes of the dual-axis fiber grating strain sensor are undistorted by transverse strain gradients. The short wavelength peak is aligned in the plane of the cylinder while the long wavelength peak is orthogonal to it. After the cure, significant transverse strain gradients appear on the short wavelength peak corresponding to transverse strain gradients in the plane of the cylinder, in the direction of the cut tow. Of the six dual-axis fiber grating strain sensors placed in the part this was the only one exhibiting this type of behavior.

The advantage of using multi-axis sensors is that the directions of the transverse strain gradients, as well as the magnitudes are known. In the case of the damage sequence involving the cut tow of Figure 3 the known orientation of the multi-axis fiber grating sensor allows the user to understand that damage is in the plane of the cylinder of the composite pressure vessel. In addition, from Figure 3 it is apparent that out of the plane of the cylinder the spectral peak associated with that direction shows no change indicating that in this direction damage did not occur. By using arrays of multi-axis fiber grating sensors the directional information may be used to localize and characterize the extent of damage. In the case of Figure 4, the single axis fiber grating sensor located near the Teflon tape defect severe transverse strain gradients arise and the evolution of damage throughout the pressure cycle is clearly evident.

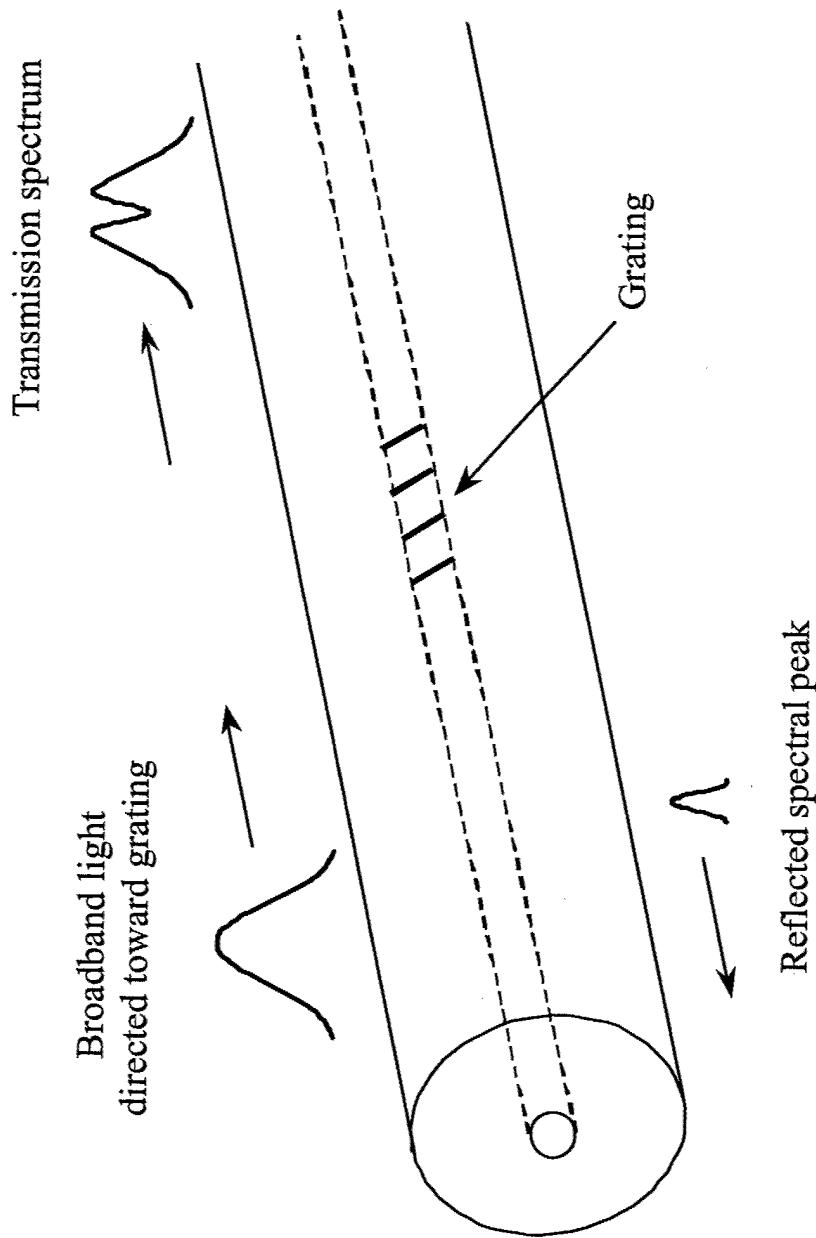
Transmission and Reflection Spectra from Fiber Bragg Grating

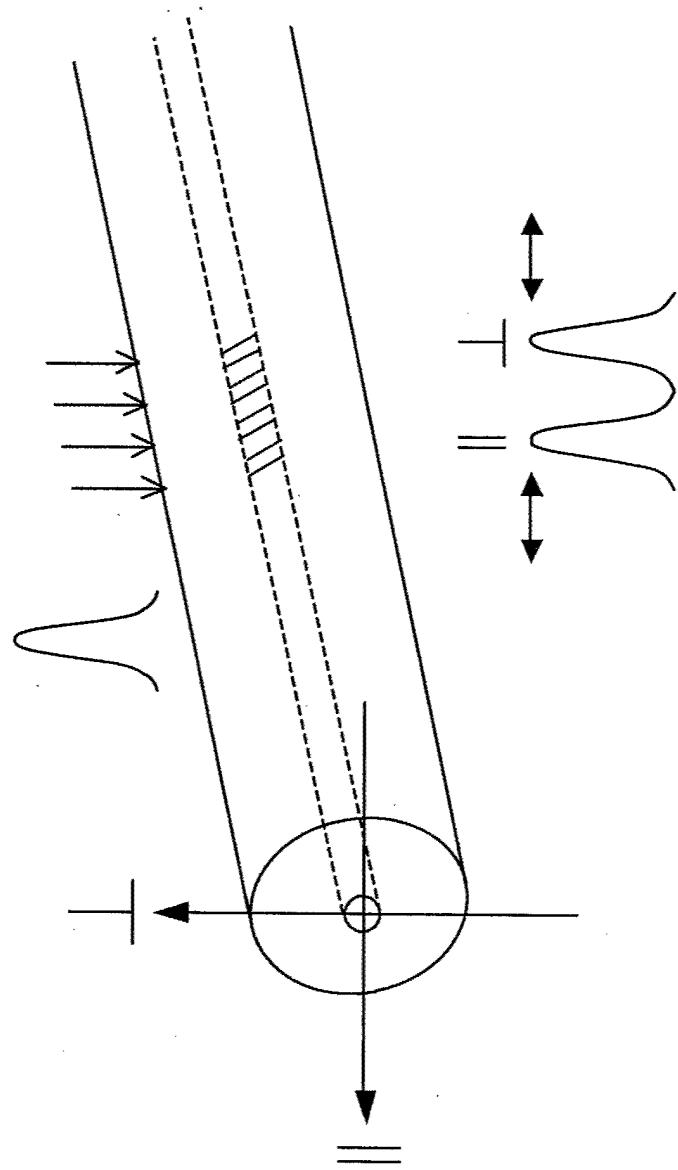
Uniform Transverse Loading

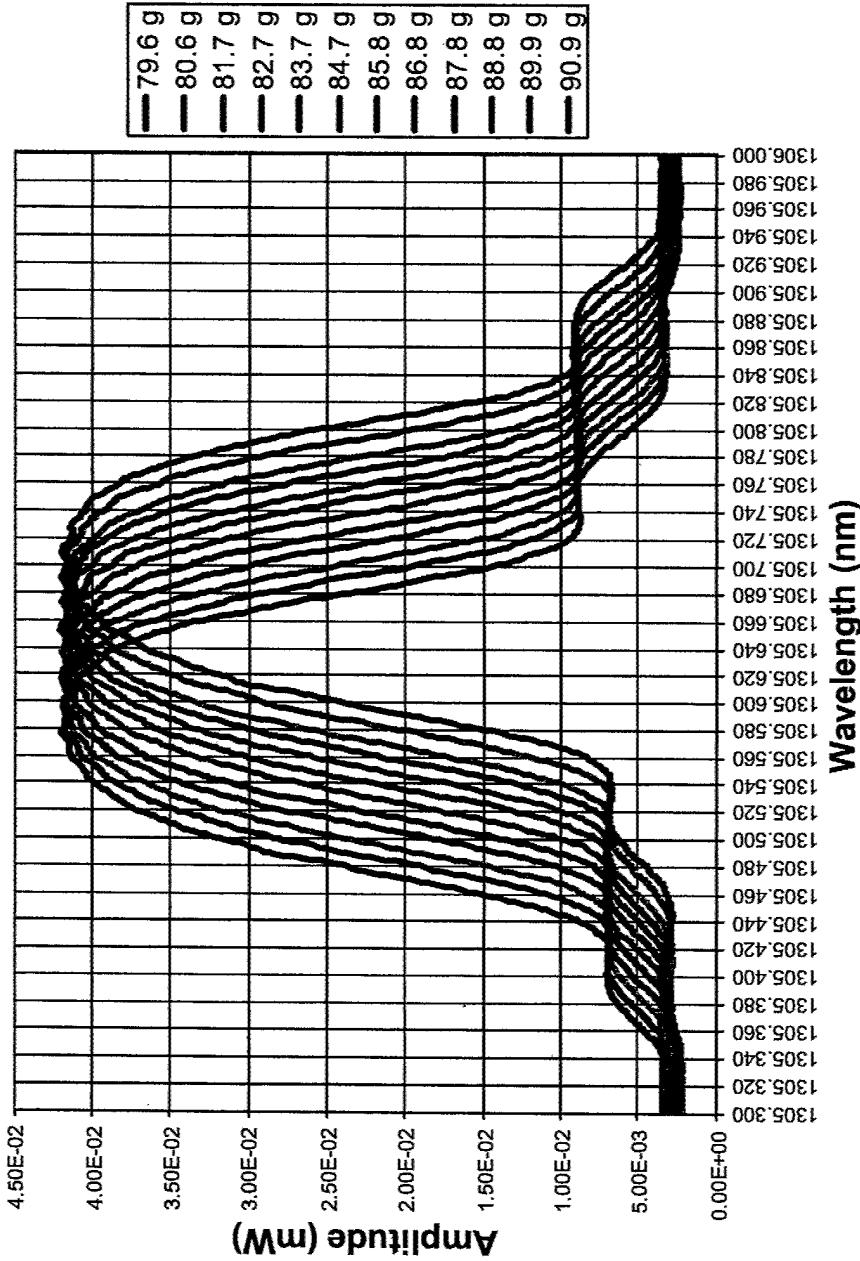
Axial Loading

Axial Loading of a 3-Axis Sensor

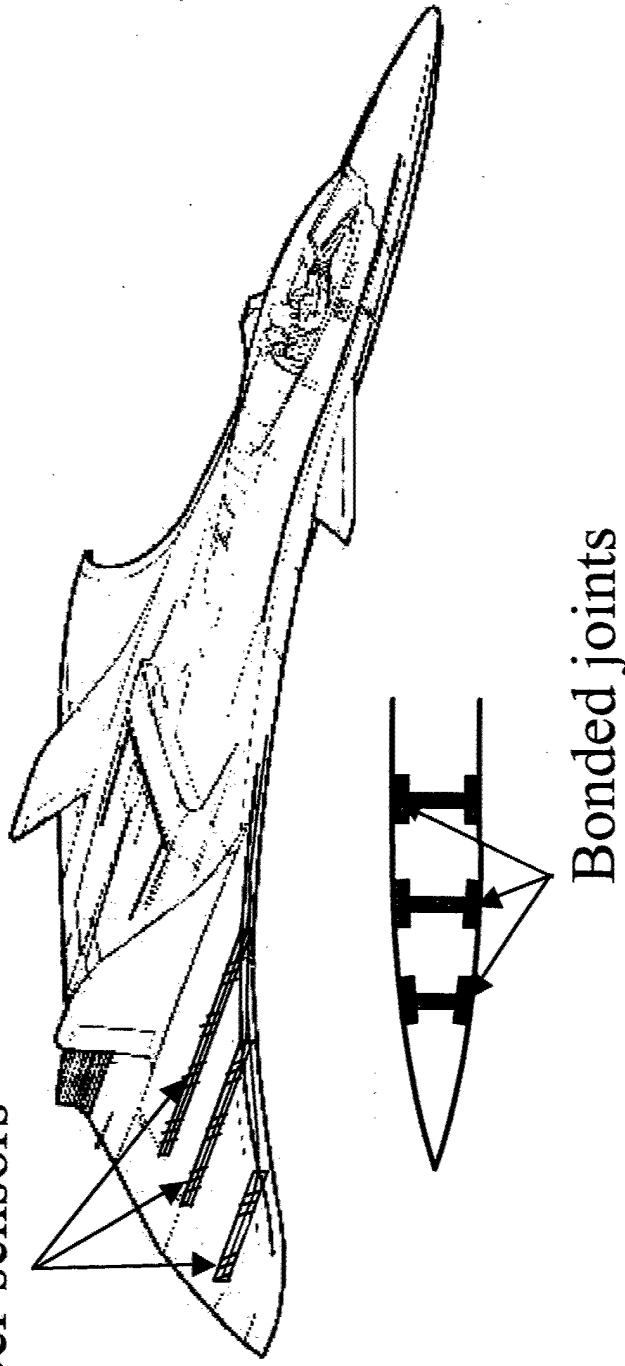
Joint Health Monitoring System

Distributed

Fiber sensors

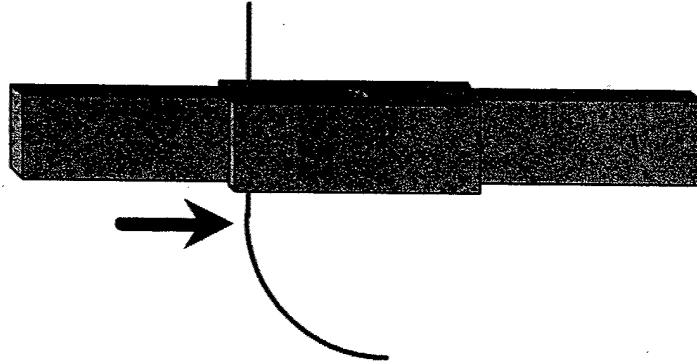
Instrumented Joint

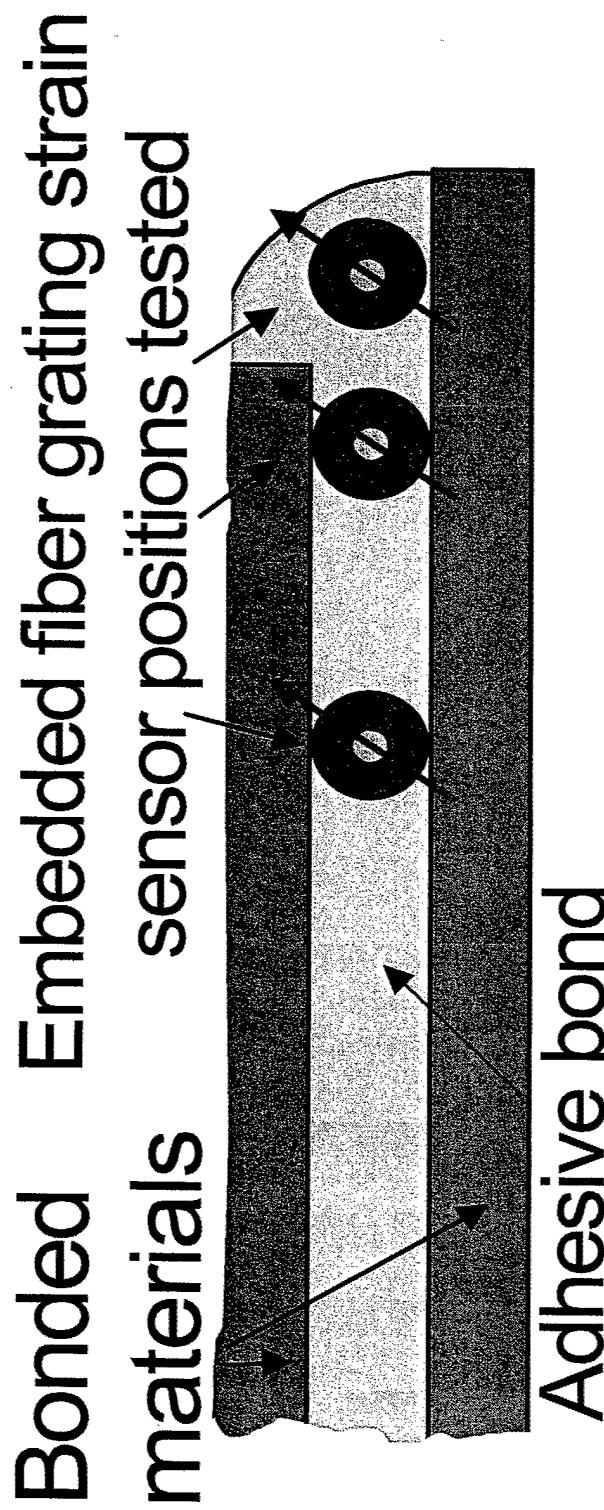
Sensors embedded in, and Retro-fitted to, an Adhesive Joint

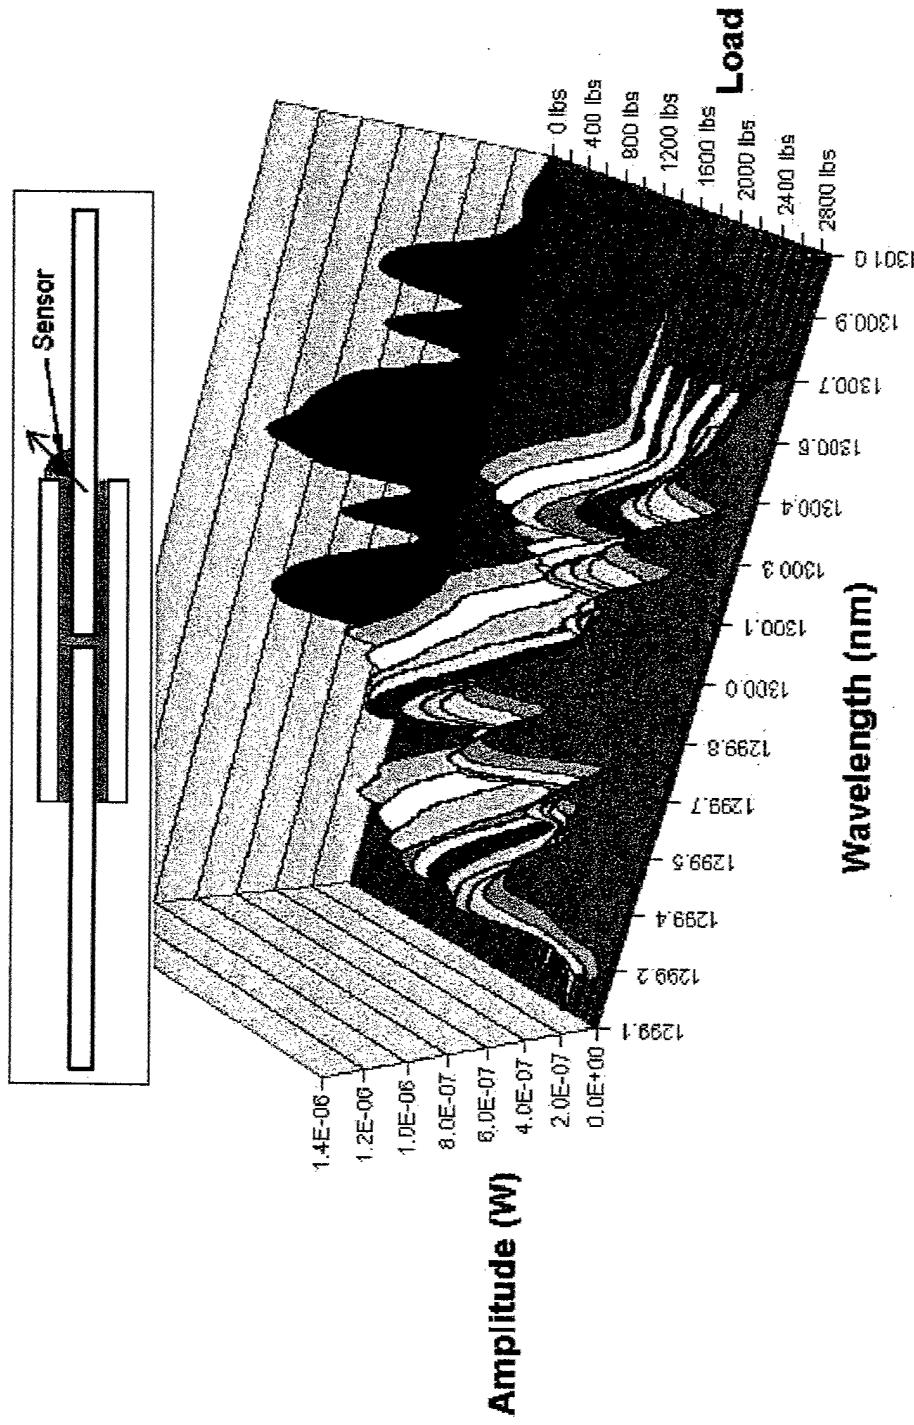
Retrofit Spectral Data

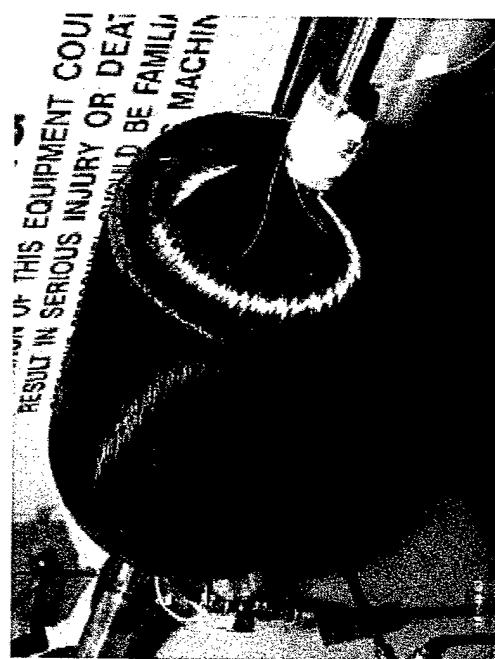
Casing with Embedded Fiber Grating Strain Sensors

Parameter	Characteristics
Composite	T700/UF3369
Liner	Approx. 12" dia. & 20" length Cross linked Polyethylene 5.7 lbs.
Winding Plan: Wind directly over plastic liner	Made by Roto Molding of Utah 3 Helical layers (0.0705 in. thick) 2 to boss - 10 deg. X 1stepped back one bandwidth -16 deg. Xsb 7 hoop plies (0.0823 in. thick) 4 tows/band 5 lbs/tow tension
Winding Sequence	X O O O Xsb O O O X O

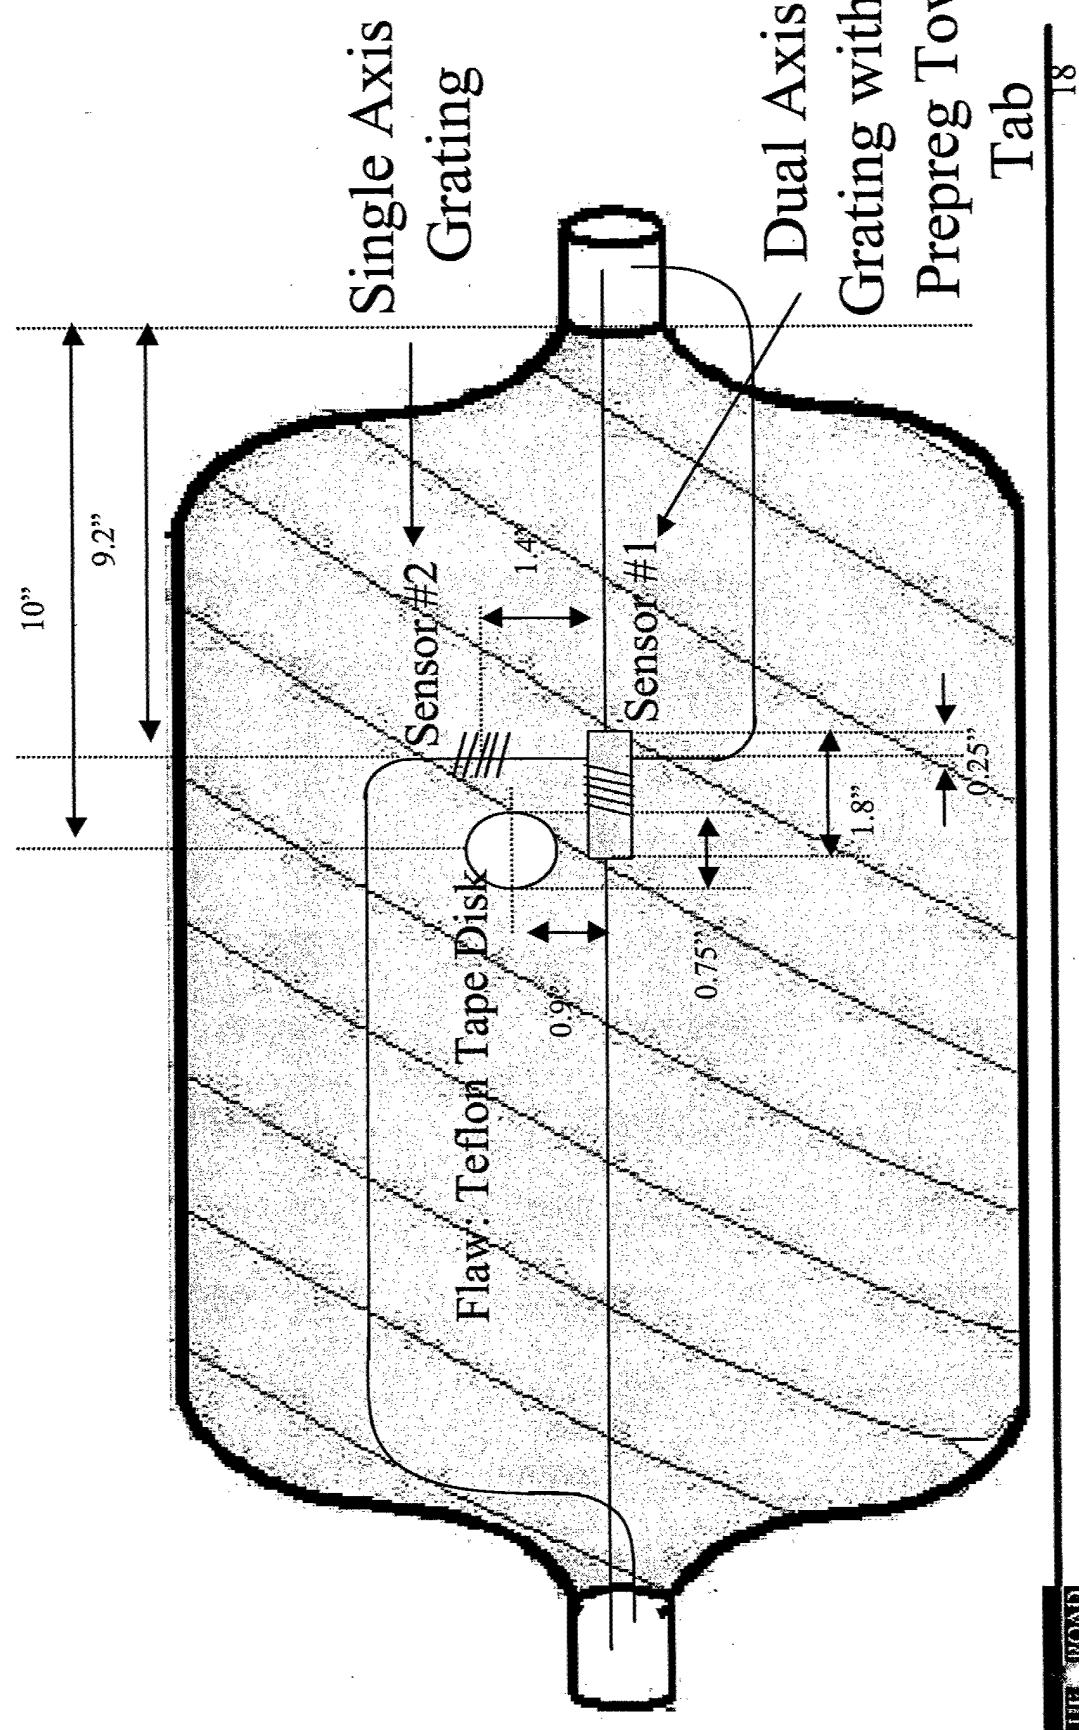
The Relative Position of Sensors #1 and #2, Which Were Placed After the First Helical Winding

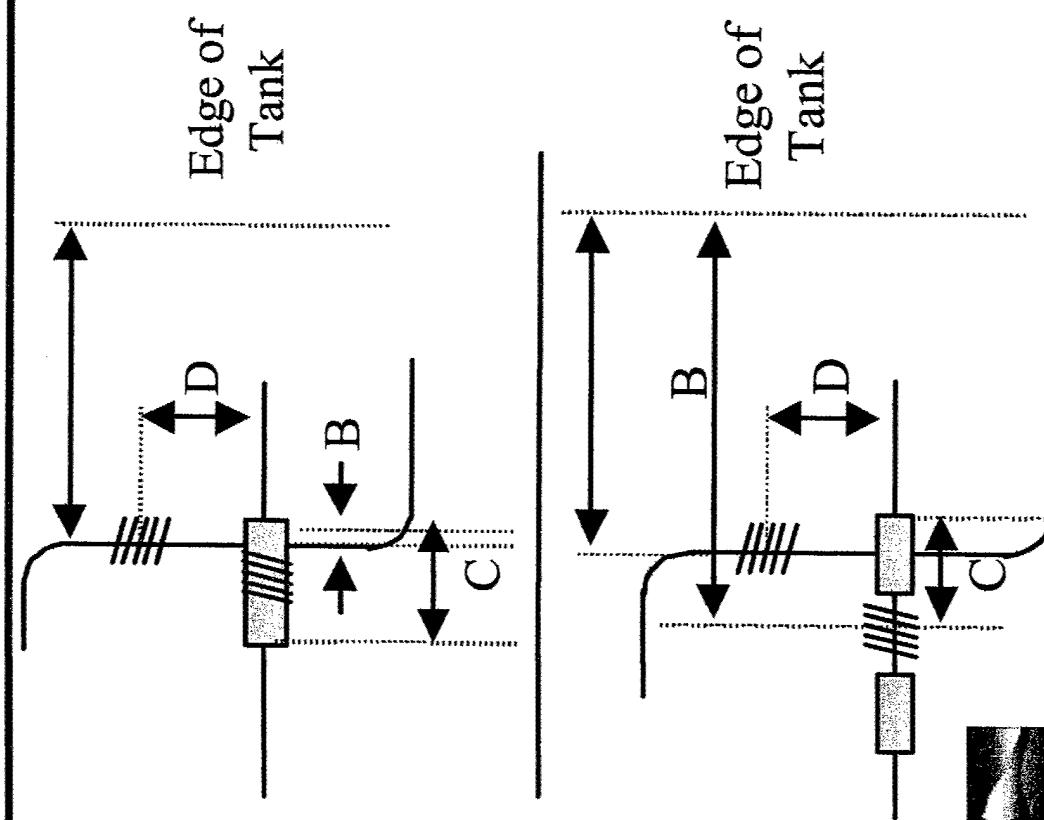
Distances Between Adjacent Sensors

Sensor Numbers ^a	A (in.)	B (in.)	C (in.)	D (in.)
1 and 2	9.2	0.25	1.8	1.4
3 and 4	9	0.2	1.75	1.2
5 and 6	9.8	0.125	1.75	1.25
11 and 12	9.5	*	*	1.75

^a Dual Axis: Sensor #1, 4, 6 and 12
Single Axis: Sensor #2, 3, 5, and 11

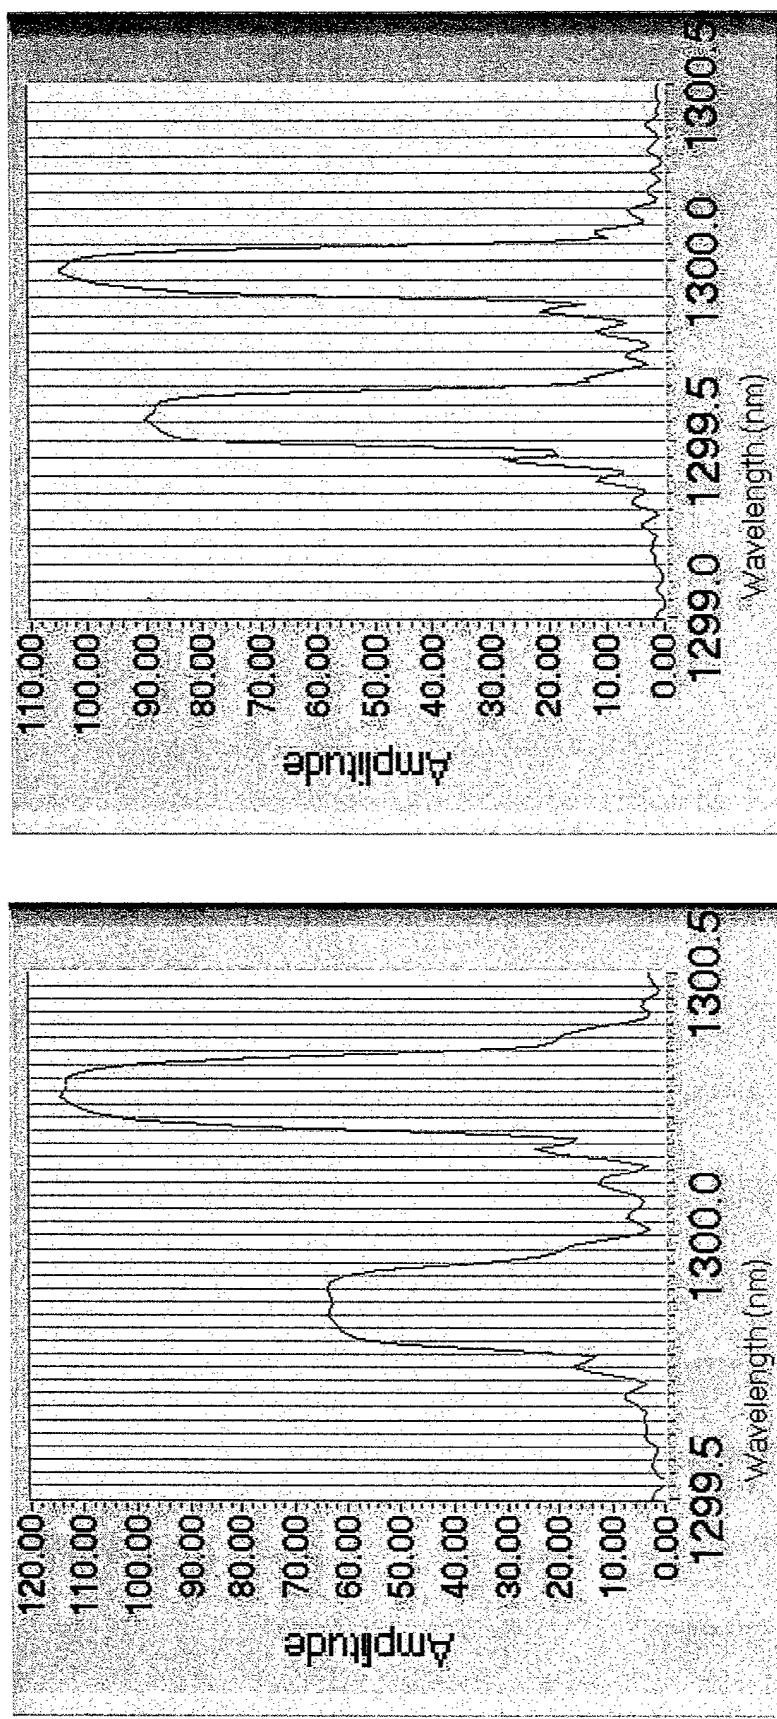
Spectral Profile of Sensor #4 (a) before and (b) after curing process

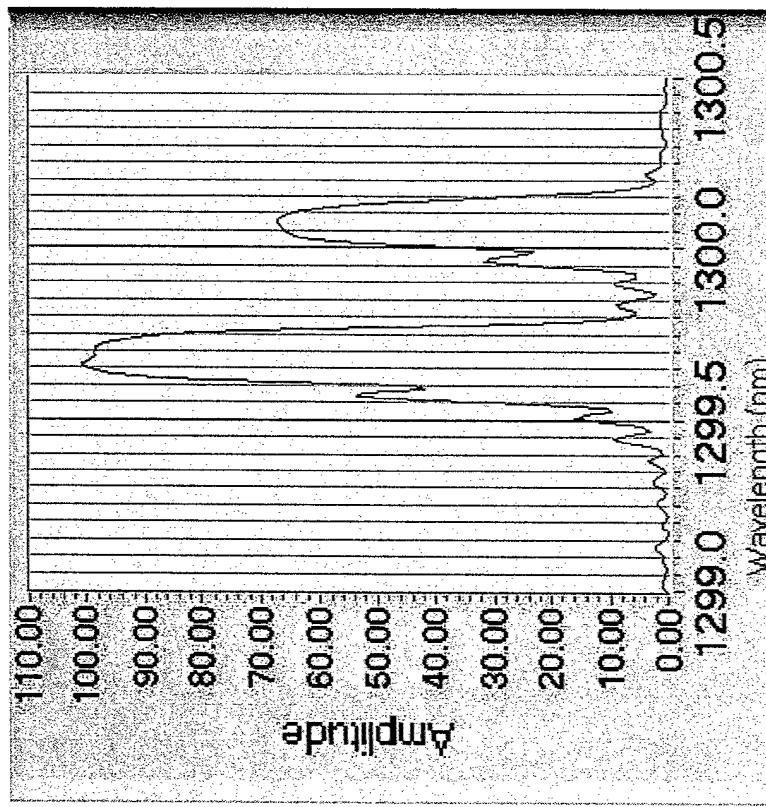
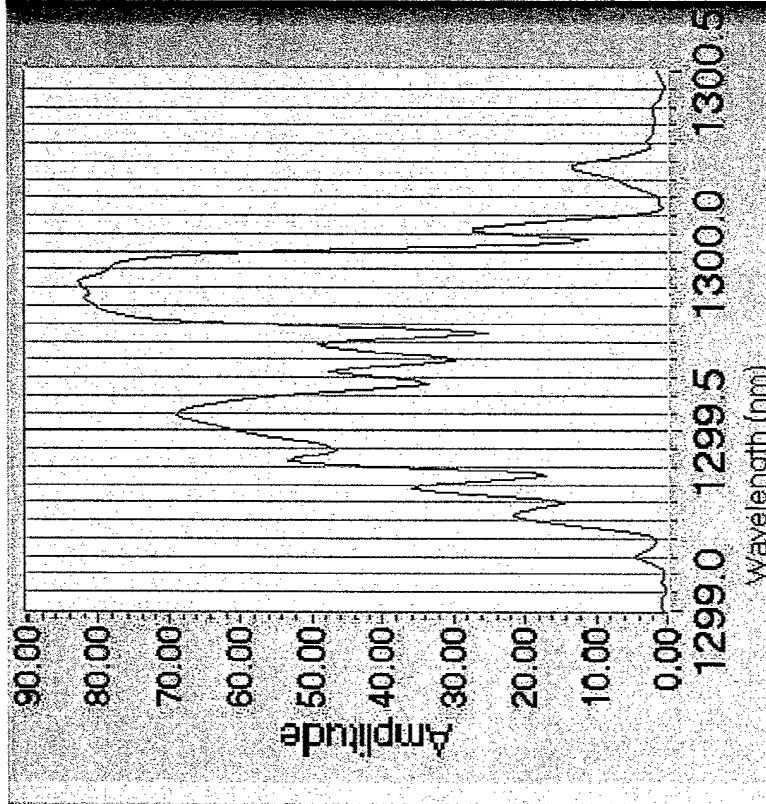
Spectral Profile of Sensor #8 (a) before and (b) after curing process

(a)

(b)

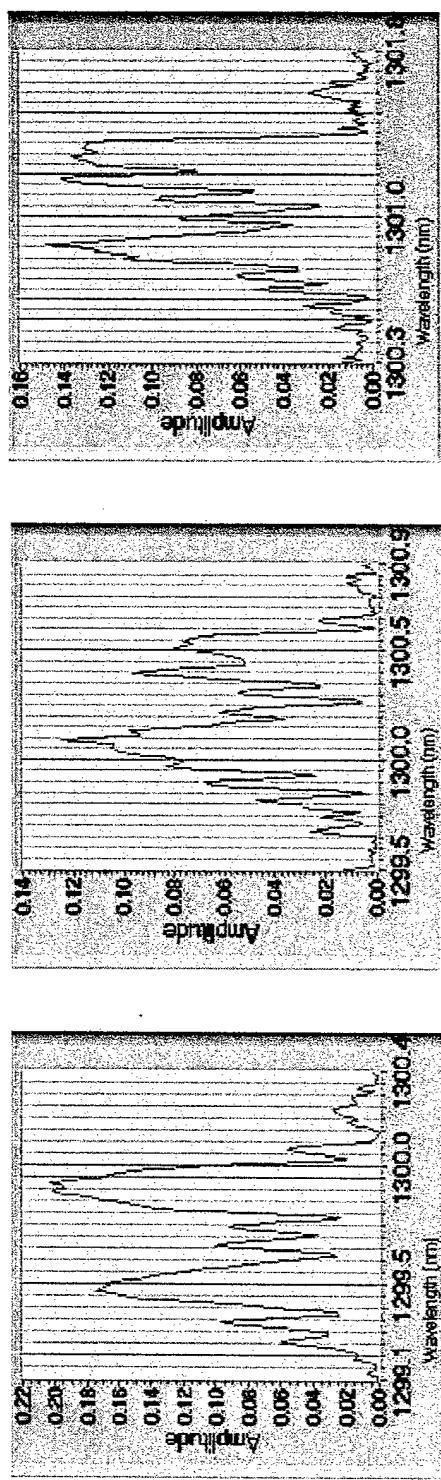
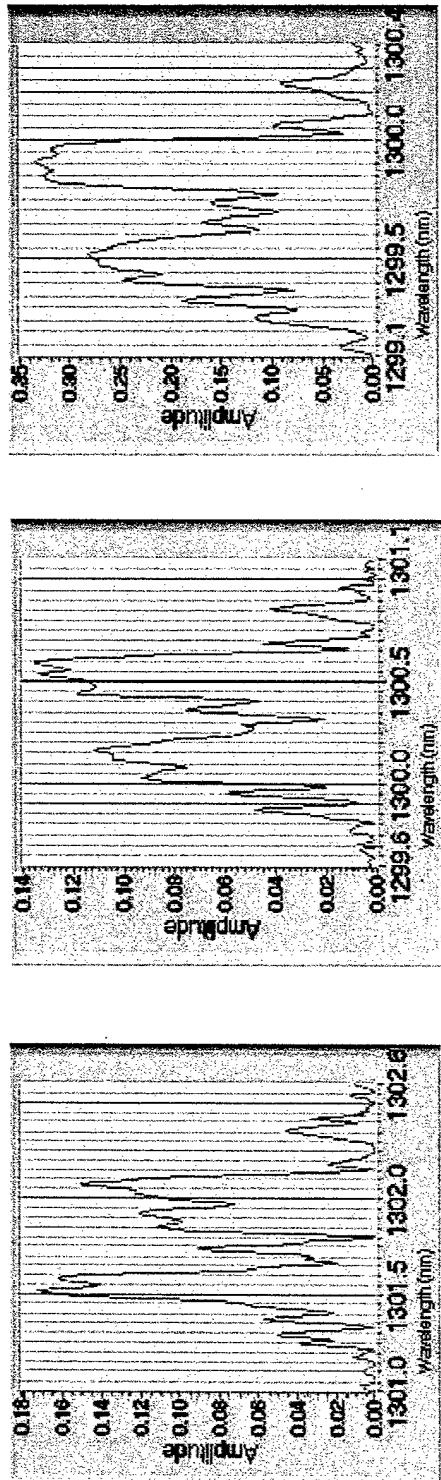
Spectral Profiles of Sensor 8 Near Cut Tow Area During 1 st Pressure Cycle

0 psi

667 psi
333 psi
1000 psi

Return to 0 psi
333 psi

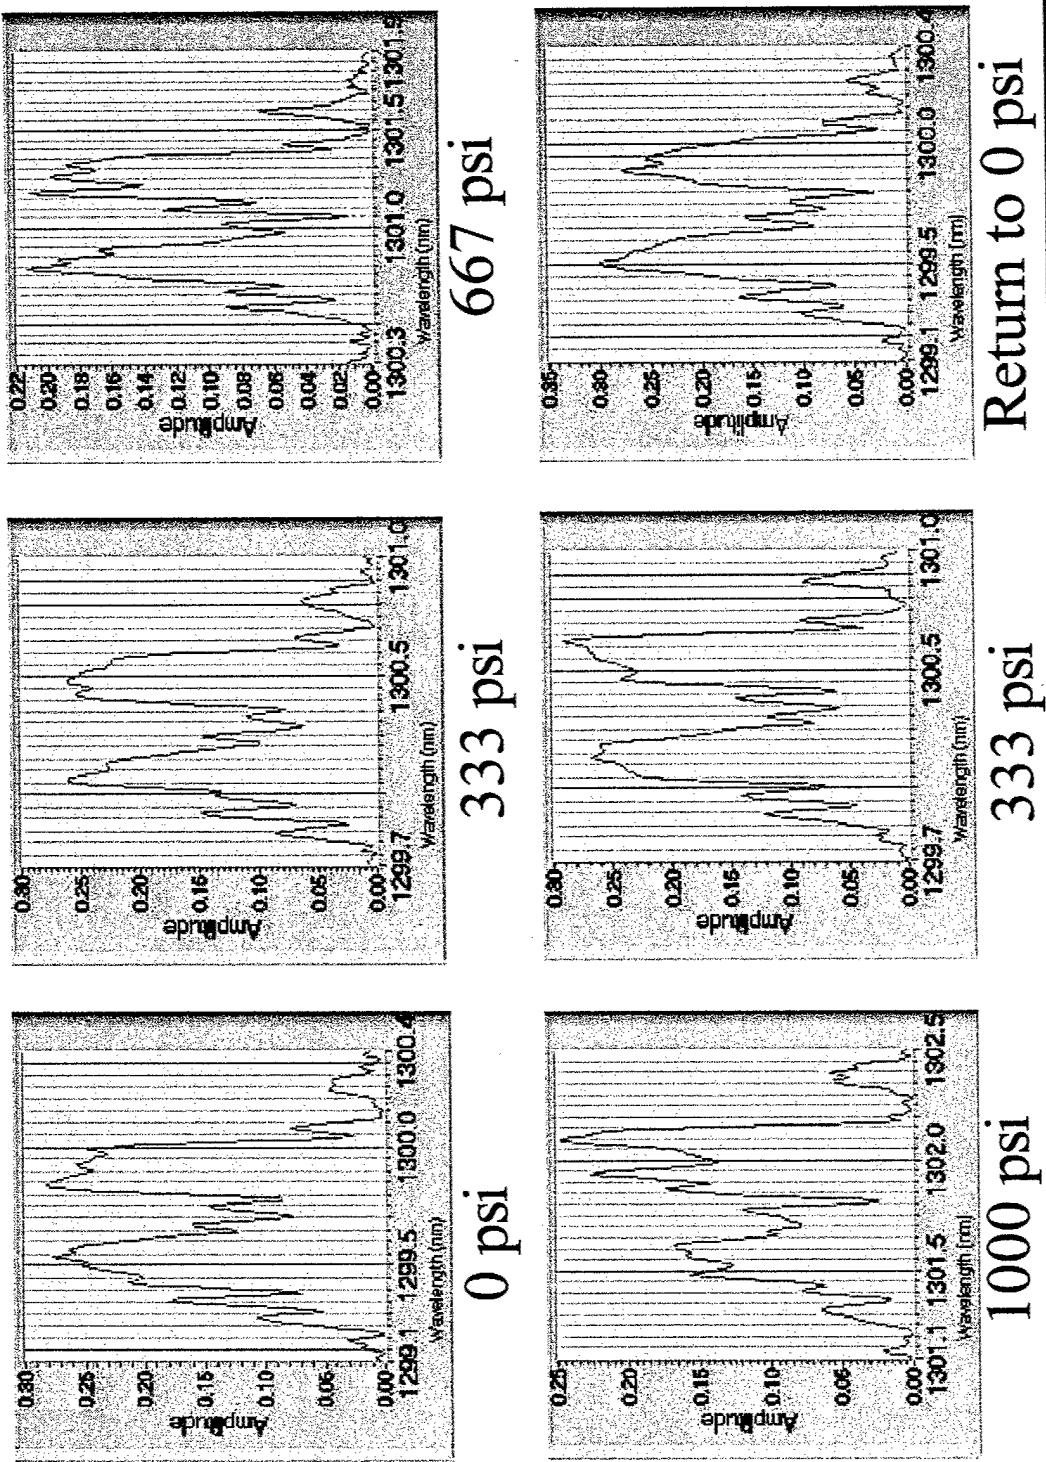
Spectral Profiles of Sensor 8 After Impact 2 Near Cut Tow Area During 3rd Pressure Cycle

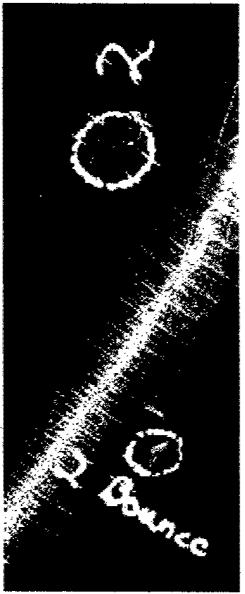
Drop Test Setup and Damage Induced

Damage induced by drop test 2 with
bounce, 15 foot pound drop on 1 cm² area,
 \approx 2.5 cm from sensors 7 and 8 near cut tow
area

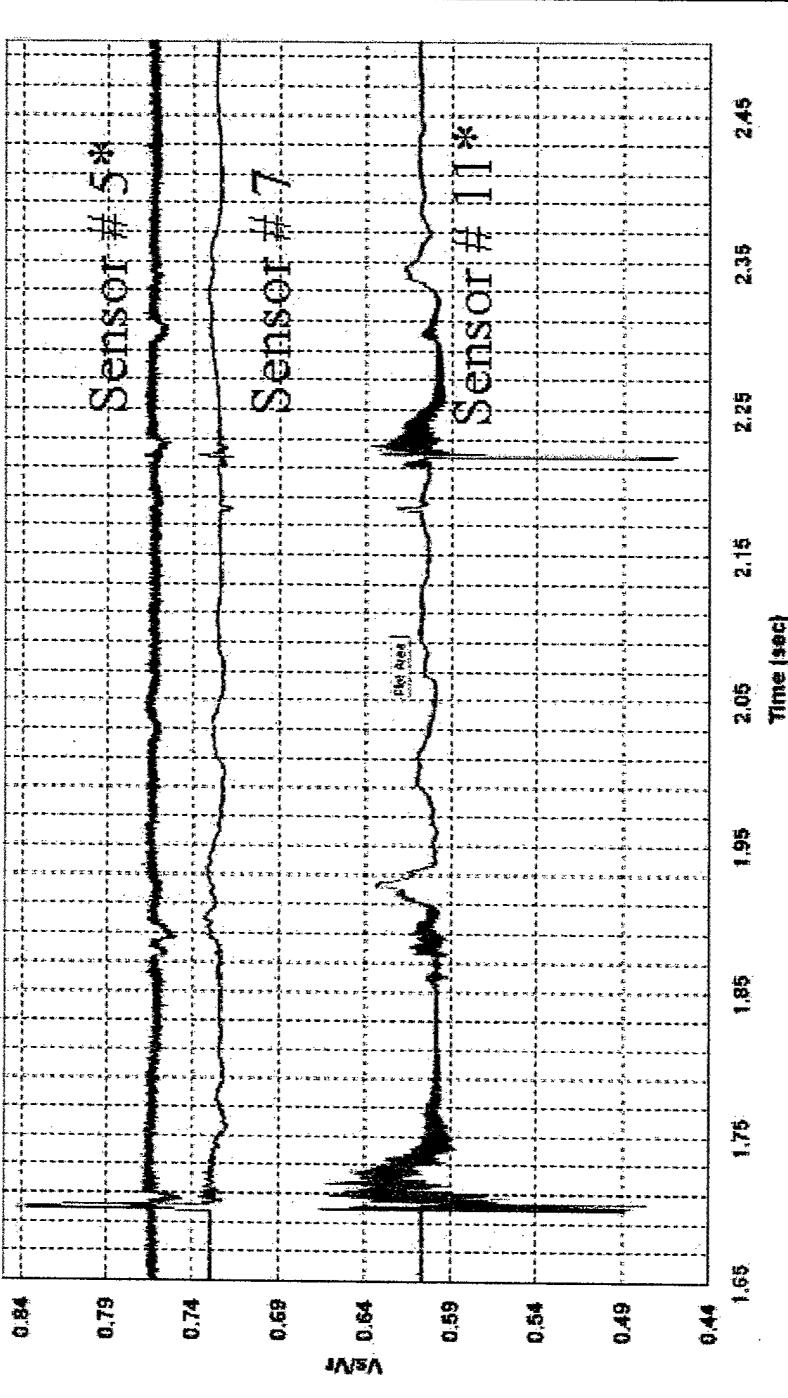
15 ft-lb Impact (and Bounce) Near Site of Cut Tow Damage and Sensor 7

*Sensor 5 is located in the same middle layer as sensor 7 but on the opposite side of the tank. Sensor 11 is on the top layer on the same side of the tank as the impact/sensor 7

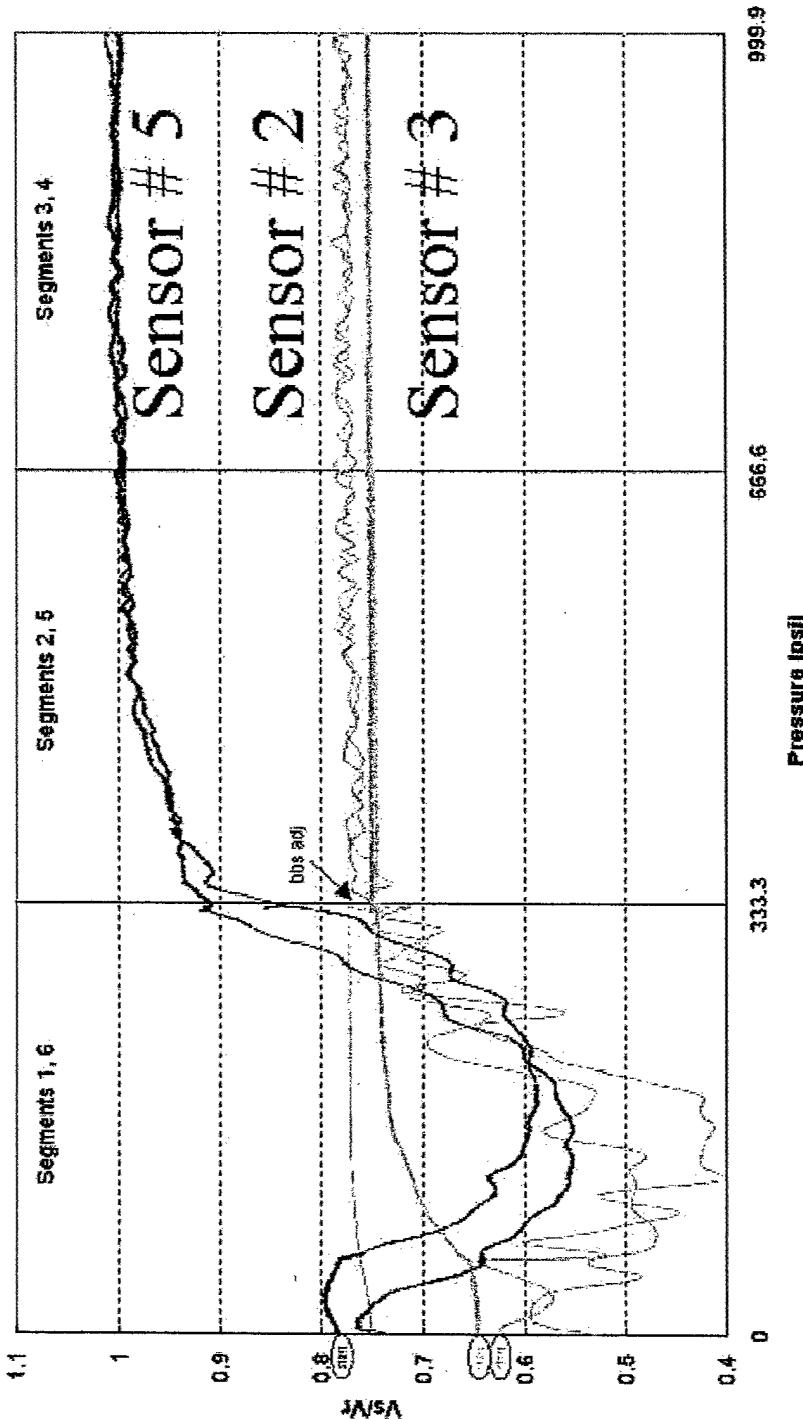
Strain Measurements Made During 1st Pressure Cycle

Sensor 2: deepest embedded layer, near Teflon tape flaw

Sensor 3: opposite side of tank, in same layer as sensor 2
